# **Analysis of Failure of a Polyethylene (PE) Gas Service Pipe (Lenoir County, NC)**

June 1976

Report for  
**North Carolina Utilities Commission**  
**Raleigh, North Carolina**

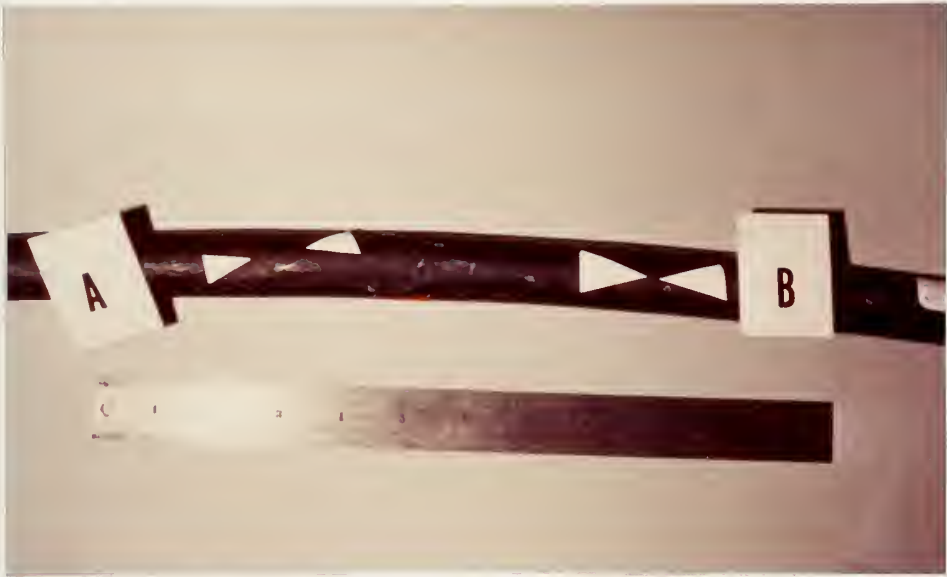
Figure 1

The two marked areas of leakage were designated as A and B. These two areas were, respectively, 80 and 65 cm from the nearest end of the overall sample, figure 1. A portion of crack A was visible on the outer wall of the pipe. A crack somewhat transverse to the longitudinal direction of the pipe was visible. This crack was approximately 2 cm in length but curved into a longitudinal groove, apparently the result of abrasion, which extended for about 11.5 cm along the outer pipe wall, consequently, the actual length of the crack could not be determined initially. Microscopic examination of area B did not reveal the presence of a crack, although numerous pits, scratches and embedded particles were observed. The pipe was then pressurized to 4 psi gauge (psig) air pressure. The leak at A was obvious, but no leak was detected at B. Subsequently, a liquid leak detector was applied over area B and the approximate location of two small leaks was determined. The pipe was then placed under the microscope, again pressurized and the leak detector applied to this area. The two leaks were located and found to be about 3 millimeters (mm) apart in the longitudinal direction and 5 mm apart in the transverse direction of the pipe. No holes were actually observed under magnification, but one leak appeared to be at or adjacent to a small piece of embedded debris. The latter leak was located in a shallow furrow in the pipe wall that appeared to have resulted from external abrasive damage.

A section of pipe, containing the two cracks, was cut from the sample. This section was about 45 cm in length with the two cuts being made approximately 15 cm to the left of crack A and to the right of crack B (see figure 1). Examination of the inside of this section showed the presence of two cracks on the inner wall at the approximate location

Examination of crack A revealed the presence of two particles, which looked like sand, embedded in the crack near the mid wall (the cylindrical surface parallel with and halfway between the inner and outer walls of the pipe) of the pipe. These particles were located about 4 mm from the end of the crack on the inner wall and were near the right end of the visible crack on the outer wall as illustrated in figure 1. The crack in the 2.7 cm section appeared to be a stress crack.

In the section of pipe between the two sections containing cracks A and B, a severely abraded area was noted on the same side of the pipe as crack A. This area is located on the outer pipe wall just to the right of the two arrows showing the location of crack A (figure 1). This area was approximately 2.5 by 2.5 cm and its center was located about 4 cm from the nearest end of the visible part of crack A. The outer wall of the pipe at this point was concave. It was also noted that three similar abraded areas exhibiting less severe damage occurred a distance of 15, 30 and 45 cm to the left of the above area as viewed in figure 1. The outer wall of the pipe was visibly deformed and concave in these areas. This concavity is typical of compressive deformation.

Examination of the pipe revealed a series of abrasion marks associated with shallower deformations of the outer pipe wall at intervals of approximately 7.5 cm, including those previously observed. That is, starting at the abrasion mark indicated in figure 1 there was evidence of a similar mark 7.5 cm to the right, located at the suspected origin of stress crack B, while to the left there was a mark 7.5 cm away located at the suspected origin of crack A. The next mark to the left was the one observed at crack C, while further to the left there were five additional marks located at 7.5 cm intervals, including the two previously noted marks at the 30 cm and 45 cm intervals from the one in figure 1. There was also some evidence, though not conclusive, of three or four additional abrasion marks to the right of crack B in figure 1. These marks appeared to be associated with the rib-like projections previously noted on the inner wall of the pipe. As a point of verification, wall thickness measurements made adjacent to the cracks and parallel to the longitudinal direction of the pipe across these areas indicated that thickness did not vary by more than about 0.0004 - 0.0005 in (0.010 - 0.013 mm), over a distance of 1 to 1.5 cm. This compares to wall thickness variations of .007 - .010 in (0.18 - 0.25 mm) when a cross section of pipe was measured circumferentially.

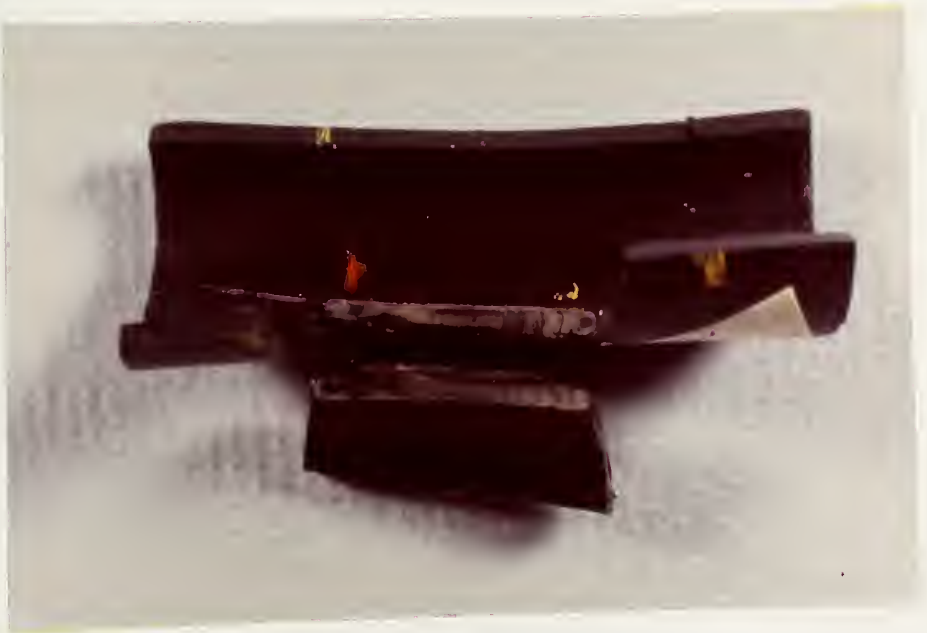
Figure 2

That portion of crack A which completely penetrated the outer wall was found to be about 2.3 cm in length. When the pipe was cut at each end of this crack, the two sections readily separated as illustrated in figure 2. The red mark on the inner pipe wall near the left end of the crack marks the location of the apparent origin of the stress crack. There was a small, raised irregularity in the crack surface of the smaller piece located about 0.25 mm from the inner wall. It was somewhat less than 0.25 mm in length in the longitudinal direction of the pipe, and was estimated to be on the order of 0.04 to 0.05 mm in width. A corresponding matching cavity was observed on the opposite crack surface on the larger piece of pipe. The yellow mark on the inner pipe wall near the right end of the crack in figure 2 indicates the locations of the two particles previously noted. These two particles fell out when the crack was separated. Examination of the crack surfaces in this area showed the presence of three very small voids and a small pit near the mid wall. It could not be determined whether the pit had been caused by the presence of one of the particles. Two small reddish spots were also observed in this area, but it could not be determined whether they were due to occlusions or to debris.

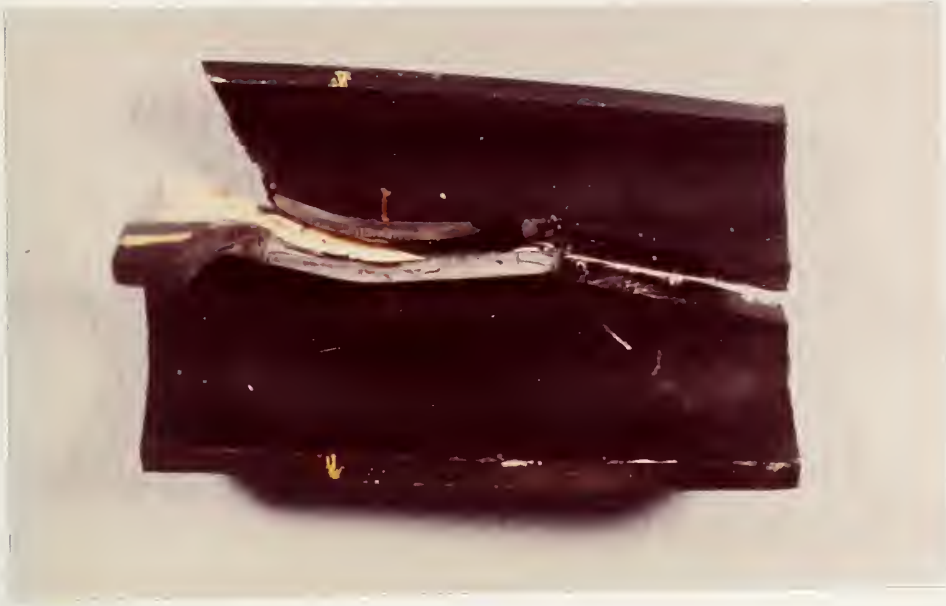
Figure 3

Crack B is illustrated in figure 3. The two portions of this crack did not separate when the pipe was cut. Examination of the surfaces of the crack in the area of the two leaks observed on the outer wall did not indicate any obvious defects in the pipe. The two sections were then bent and broken apart. There was some visual evidence that the crack had penetrated the outer wall for a distance of about 6 mm at the right end of the crack in the area of the two leaks. The red mark on the inner wall is the location of the probable point of initiation of the stress crack. The larger piece of pipe had a very small irregularly shaped pit, located about 0.25 mm from the inner wall, and approximately 0.25 mm in diameter, at the apparent initiation point. A similar, but much shallower pit was observed on the opposite crack surface. It could not be determined whether this pit was a void or had been caused by the presence of an occluded particle. Two small voids were found near the mid wall of the pipe, in the crack surface, but neither appeared to have been a crack initiation point.

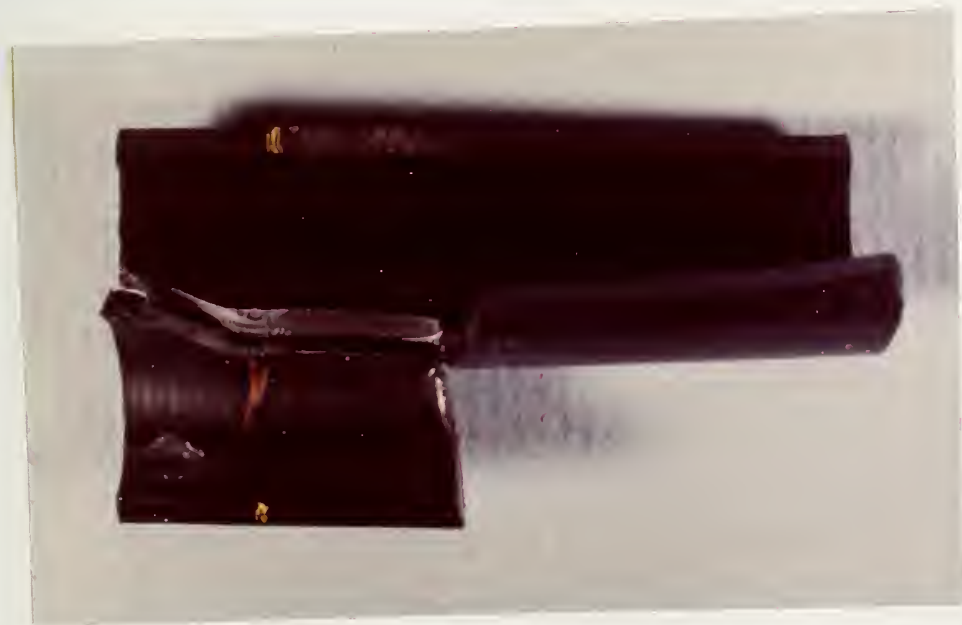
Figure 4

Attempts to separate crack C indicated that this crack did not extend much beyond the mid wall of the pipe. The crack was forced open, resulting in some tensile failure, in order to examine the crack surfaces. Although the point of origin of the crack seemed quite obvious, there were no indications of any artifacts, voids, or occlusions to enhance crack formation. The apparent origin of the crack was near the point of directional change in the crack, as illustrated in figure 4.
